RADING SAFETY PERFORMANCE IN RETROFITTING TRAFFIC RAILING SYSTEMS

September 1976
Final Report

Prepared for
FEDERAL HIGHWAY ADMINISTRATION
Offices of Research & Development
Washington, D. C. 20590

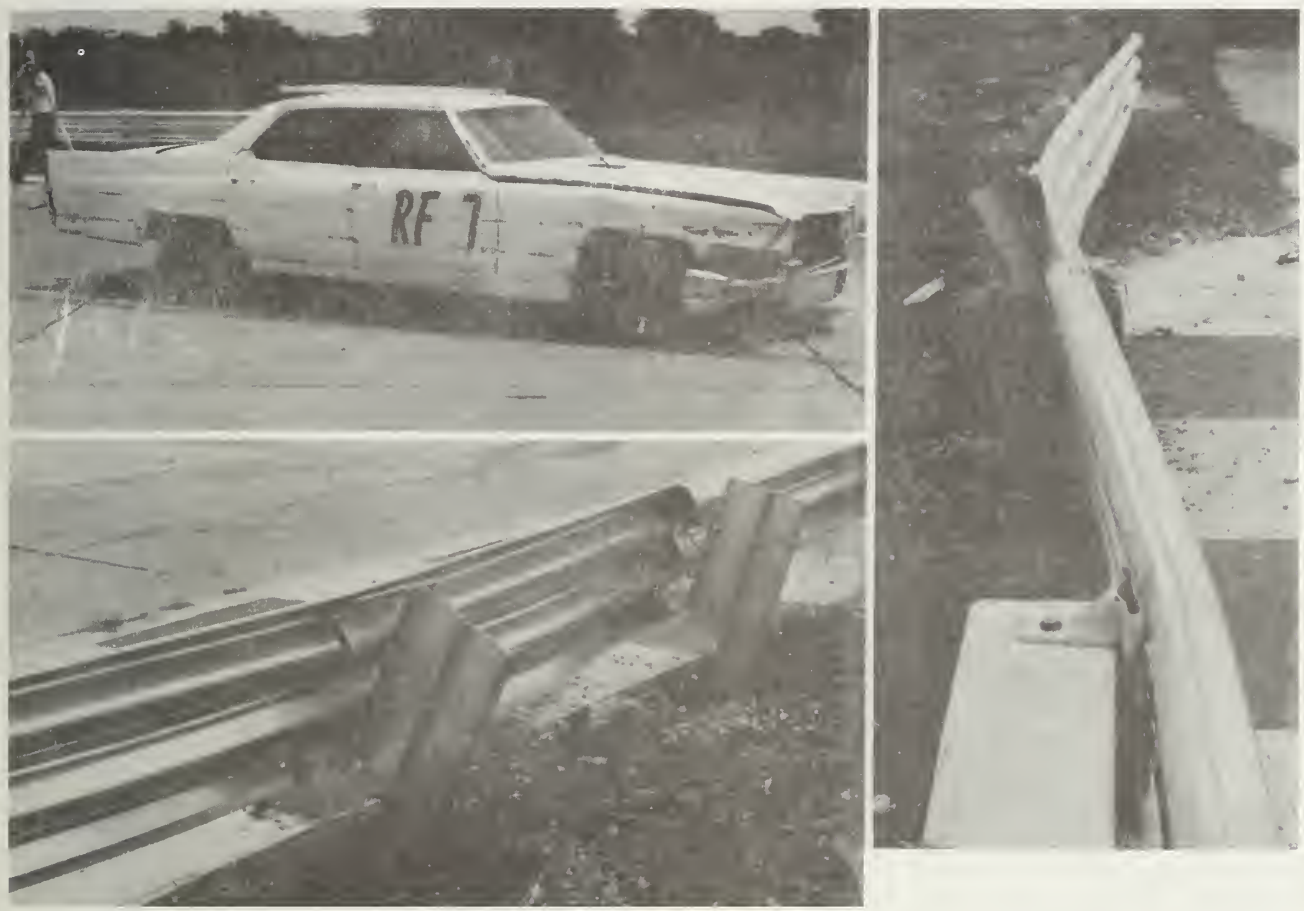
FIGURE 20. TEST RF-7 VEHICLE AND INSTALLATION DAMAGE

Test RF-7. The 4700-lb (2132 kg) 1969 Cadillac Sedan deVille impacted the single thrie beam rail in the transition area at 60.1 mph (26.9 m/s) and 25-deg angle. As shown in Figure 19, the vehicle impacted the rail 4.6 ft (1.4 m) upstream of the second guardrail post off the bridge deck and was smoothly redirected. Maximum 50-ms average vehicle accelerations determined from accelerometer data were −4.0-g longitudinal and −7.5-g lateral; maximum permanent rail set was 1.8 ft (0.55 m) after reaching a maximum dynamic deflection of 3.65 ft (1.11 m). Installation and vehicle damage is shown in Figure 20. The vehicle was driven back to the impact area following the test.

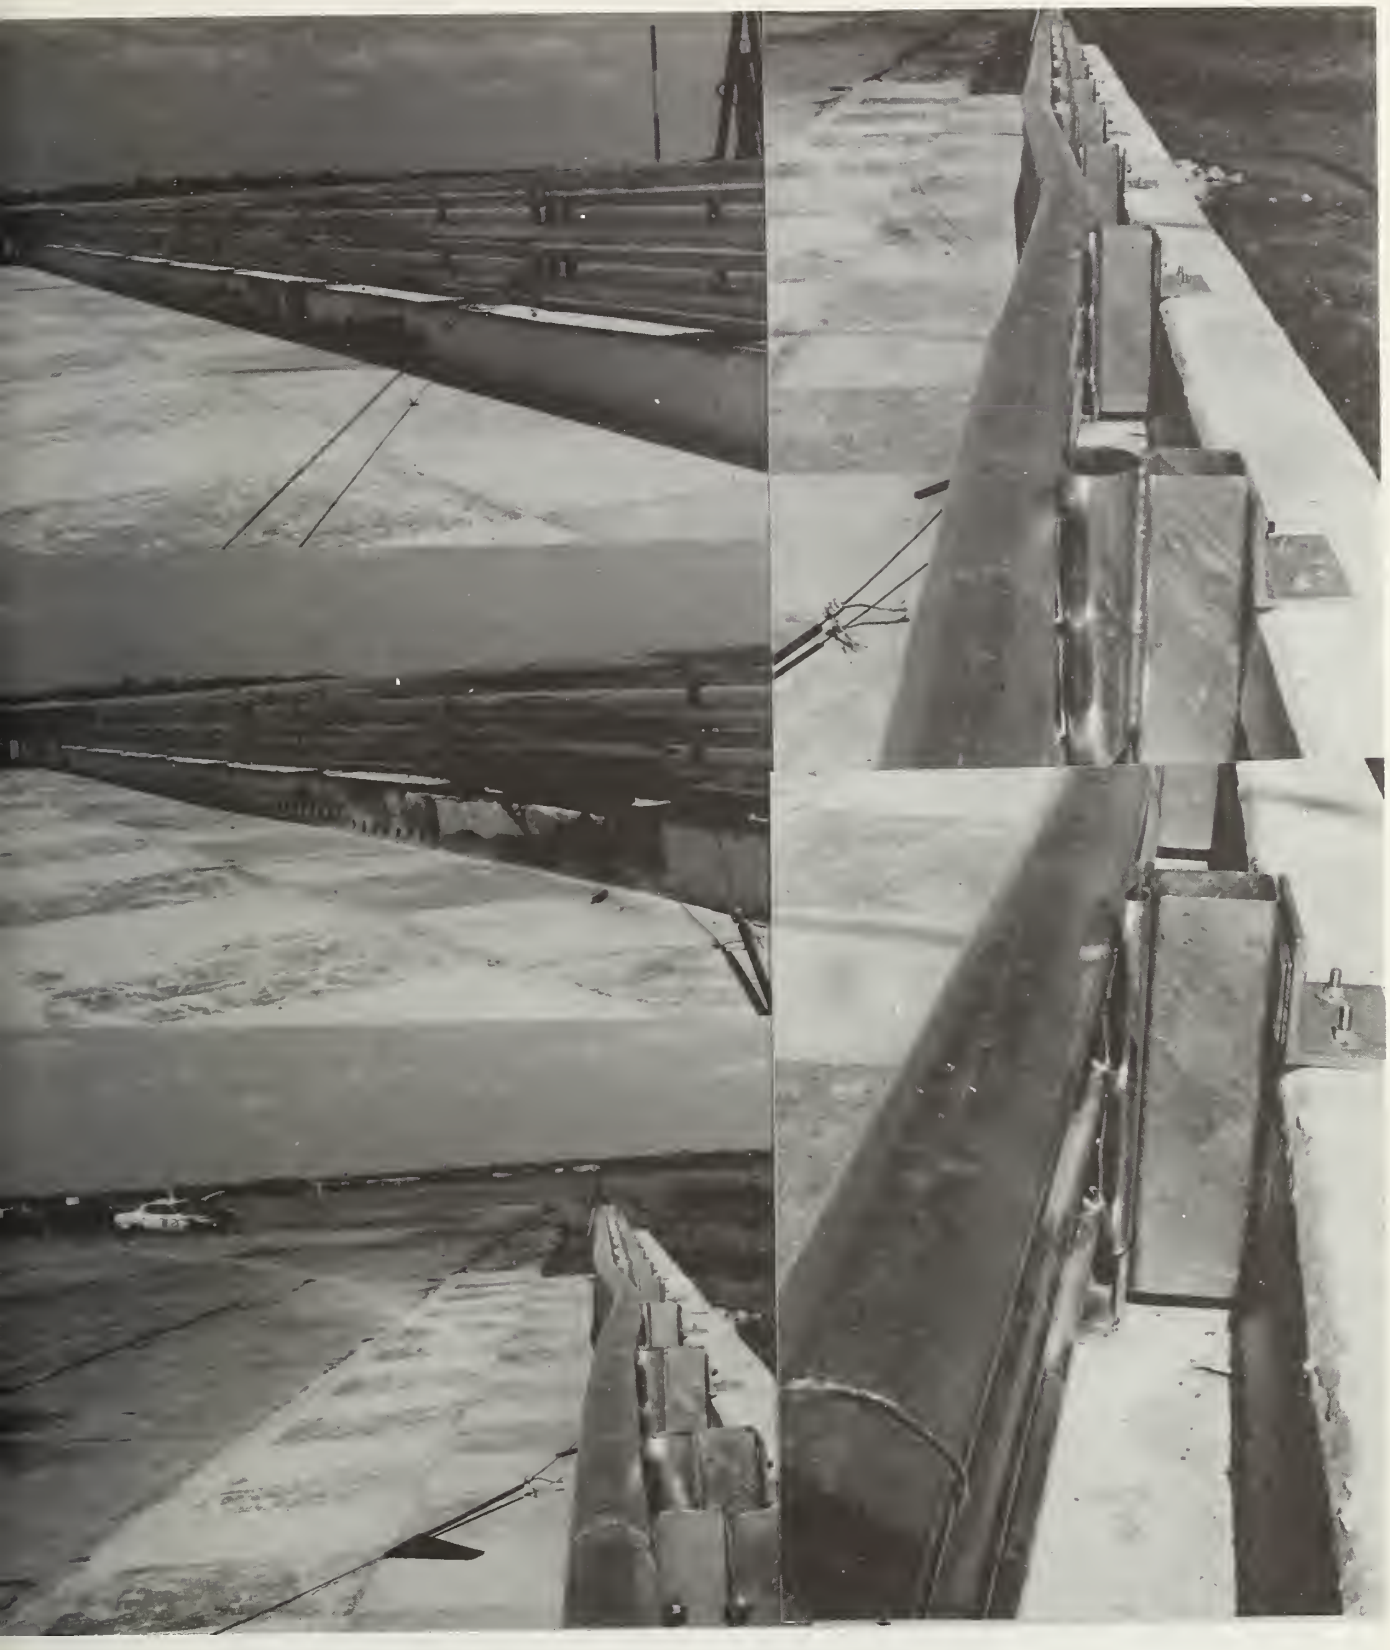
FIGURE 33. VIEWS OF TEST RF-2 INSTALLATION DAMAGE

Structural Adequacy. Vehicles impacting in the bridge rail section (Tests RF-1 and RF-2) were contained and smoothly redirected. The installation remained intact during the collisions and could have sustained additional hits prior to damage repair.

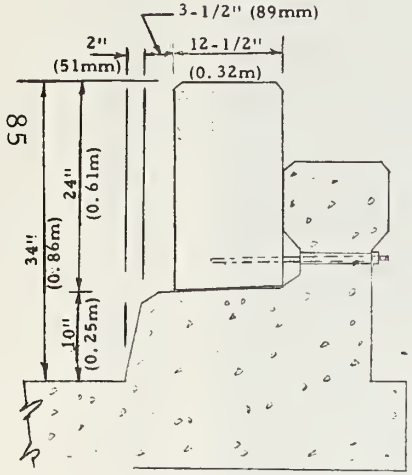
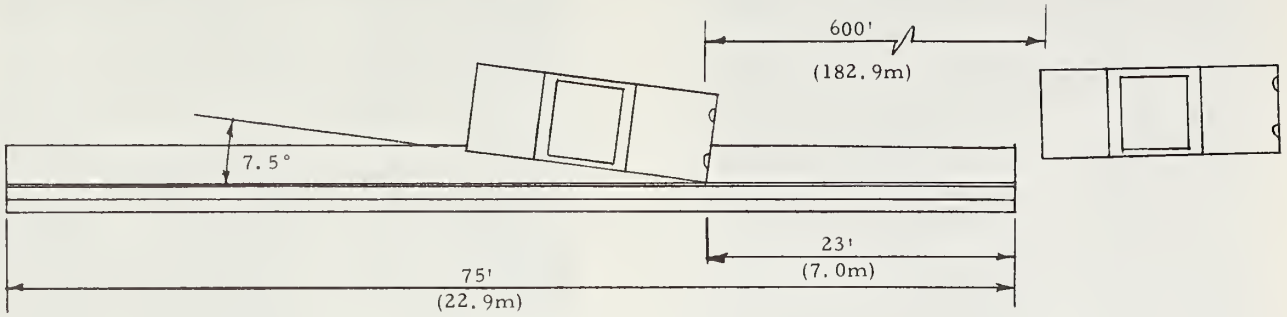
FIGURE 50. SUMMARY OF CRASH TEST RF-18 RESULTS

Impact Speed....65.3 mph (29.2 m/s)
Impact Angle ..... 7.5 deg
Exit Angle ..... 4.8 deg
Vehicle Accel (max 50 ms avg)
Lateral (cine/elect.).. -5.6g/-4.5g
Long. (cine/elect.)... -6.5g/-2.6g
Resultant (cine/elect.) .. 7.9g/5.1g
Vehicle Rebound Distance.. 10 ft (3m)
Vehicle Damage
TAD 1-RFQ-2
VDI 01FRES2
Max. Rail Deflection 0/0
(dynamic/permanent)

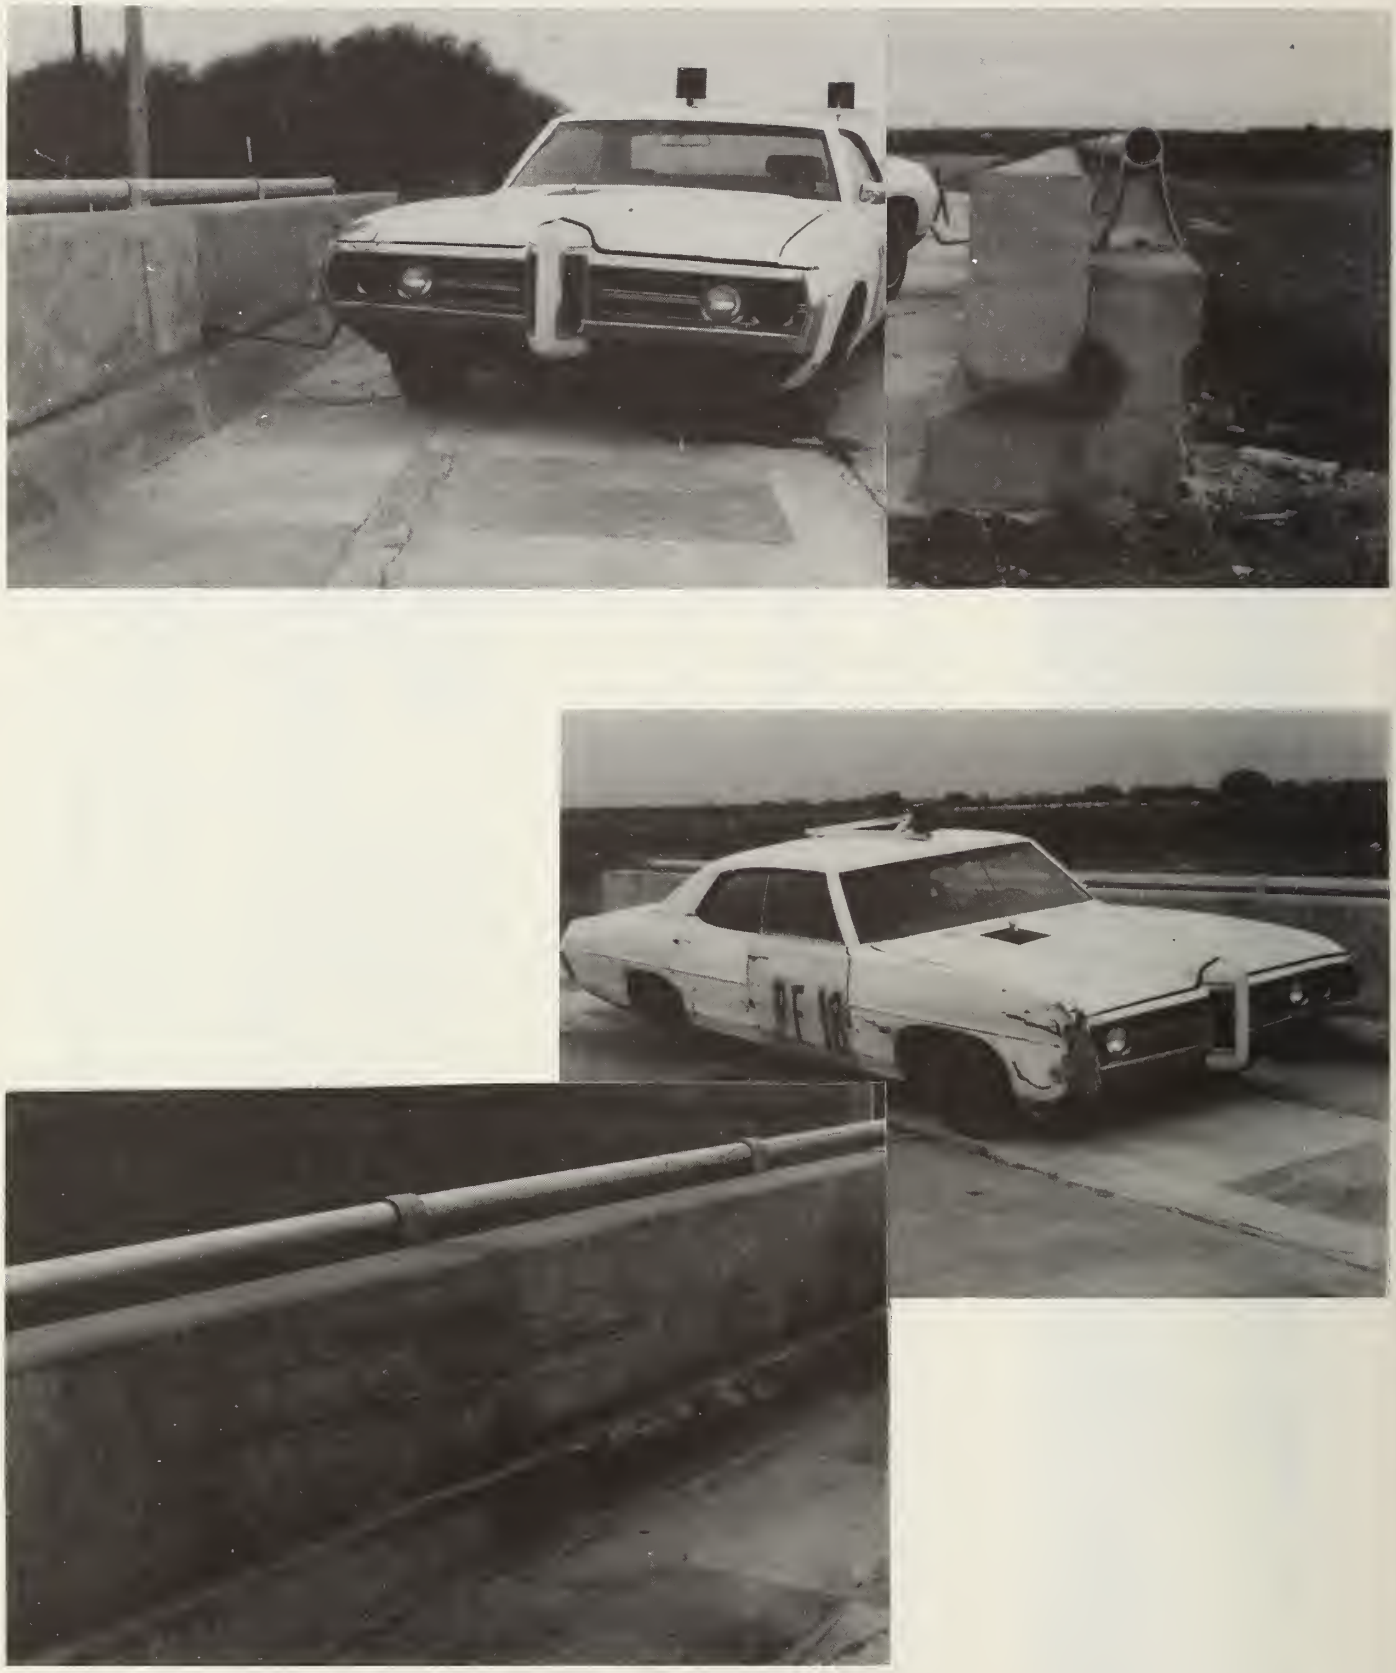
FIGURE 51. VIEWS OF BARRIER AND VEHICLE
BEFORE AND AFTER TEST RF-18

Installation and vehicle damage are shown in Figure 51. Bridge rail damage was minor and consisted of scuffing of concrete curb and retrofit beam. Subsequent safety performance of the bridge rail would not be impaired by this damage. Damage to the right front panel was minimum and did not affect the driveability of the vehicle.

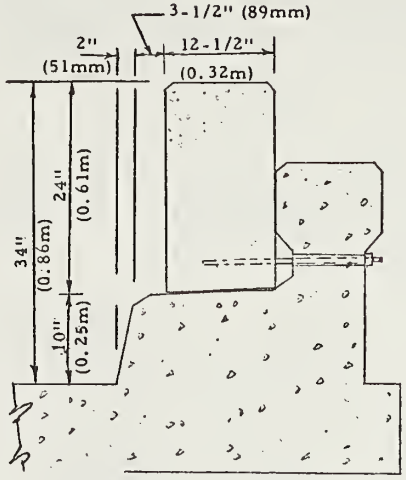
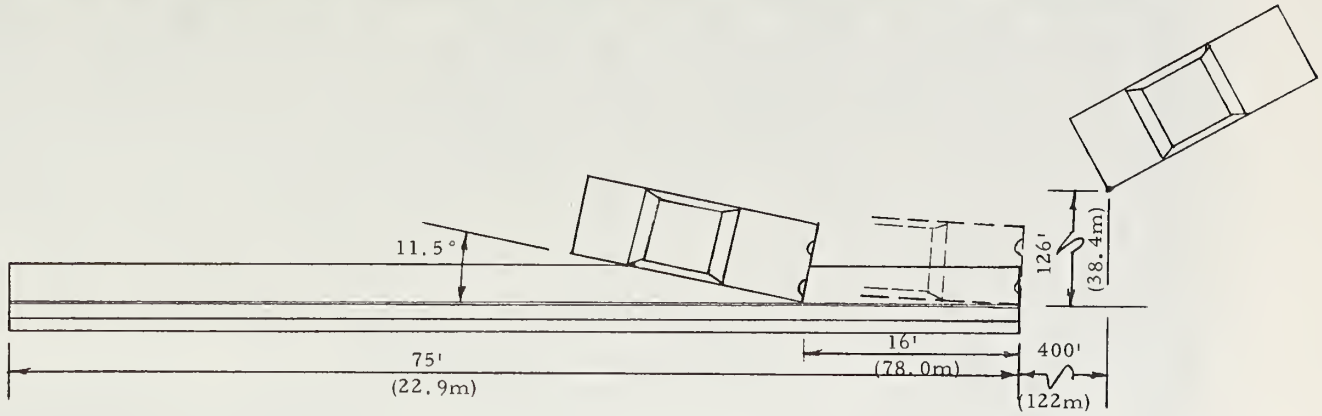
FIGURE 53. SUMMARY OF CRASH TEST RF-19 RESULTS

Impact Speed ..... 60.6 mph (27.1m/s)
Impact Angle ..... +11.5
Exit Angle ..... +2.5
Vehicle Accel (max 50 ms avg)
Lateral (cine/elect)..... -7.5g/-4.9g
Long. (cine/elect) ..... -6.3g/-4.4g
Resultant (cine/elect)..... 9.8g/6.3g
Vehicle Rebound Dist. ...126 ft (38.4m)
Vehicle Damage
TAD 1-RFQ-4
VDI 01FRES4
Max. Rail Deflection 0/0
(dynamic/permanent)

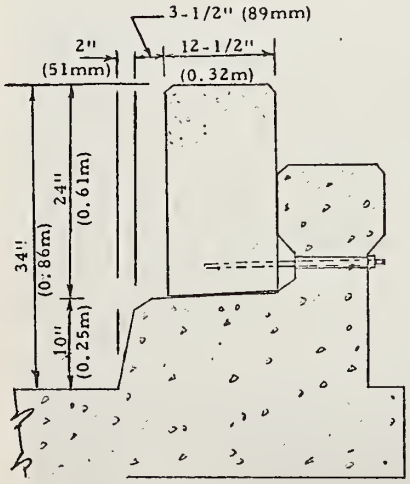
FIGURE 54. SUMMARY OF CRASH TEST RF-20 RESULTS

Impact Speed	55.4 mph (24.8m/s)
Impact Angle	+9.2 deg
Exit Angle	-12.0 deg
Vehicle Accel (max 50 ms avg)	
Lateral (cine/elect.)	-1.6g/-8.3g
Long. (cine/elect.)	-2.1g/-4.3g
Resultant (cine/elect.)	2.6g/9.4g
Vehicle Rebound Distance	15 ft (4.6m)
Vehicle Damage	
TAD	1-RFQ-2
VDI	01FRES2
Max. Rail Deflection (dynamic/permanent)	0/0

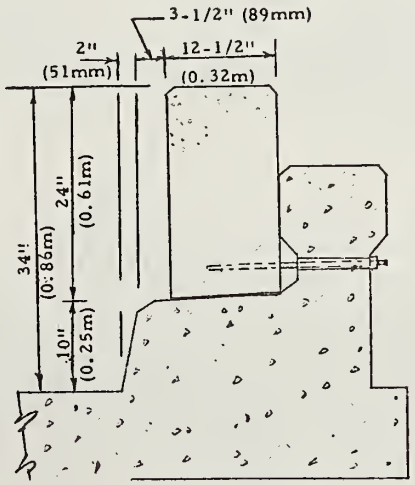
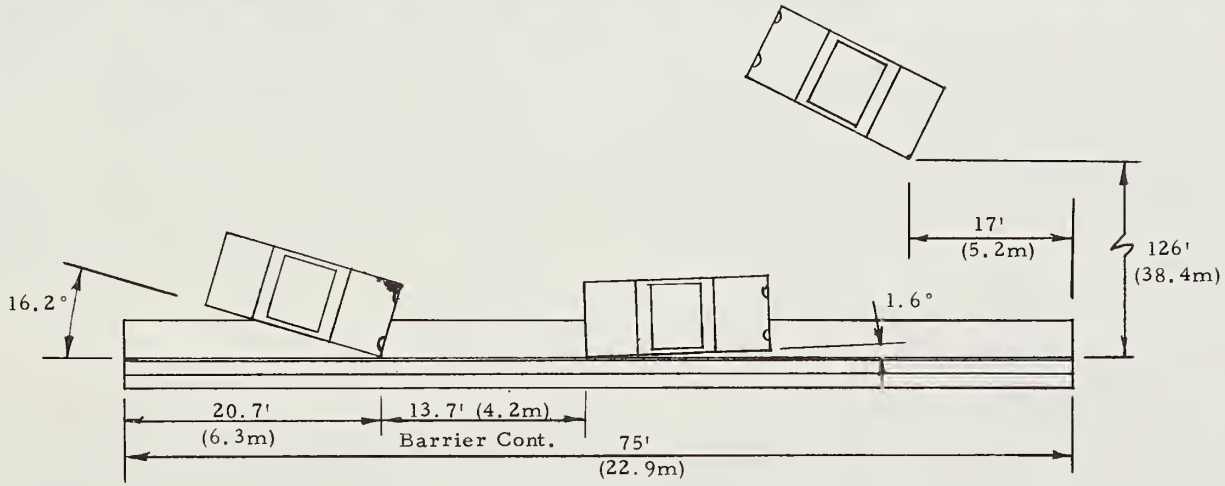
Installation and vehicle damage is shown in Figure 57. Bridge rail damage was minor and consisted of scuffing of concrete curb and retrofit beam. Subsequent safety performance of the bridge rail would not be impaired by this damage. Damage to the vehicle was concentrated at the right front panel and grill area. The bumper and grill were jammed into the radiator.

Impact Speed	44.1 mph (19.7m/s)
Impact Angle	16.2 deg
Exit Angle	-1.6 deg
Vehicle Accel (max 50 ms avg)	
Lateral (cine/elect.)	-4.1g/-6.3g
Long. (cine/elect.)	-3.6g/-5.2g
Resultant (elect.)	5.4g/8.1g
Vehicle Rebound Distance	126 ft (38.4m)
Vehicle Damage	
TAD	1-RFQ-3
VDI	01FRES4
Max. Rail Deflection (dynamic/permanent)	0/0

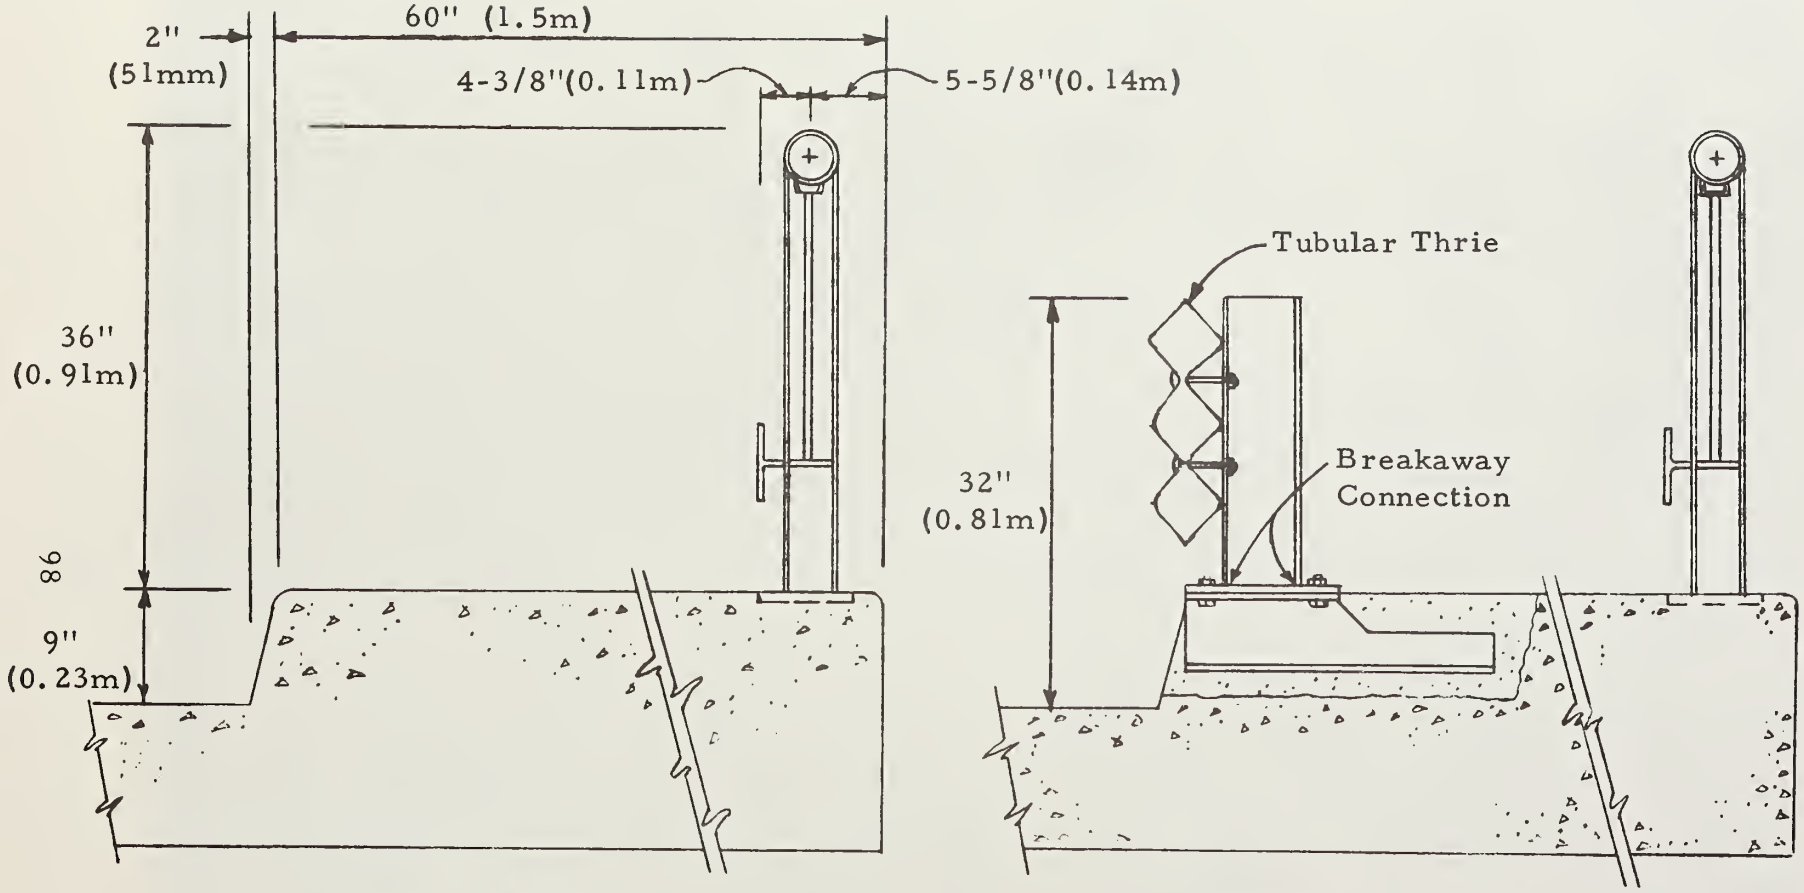
Installation and vehicle damage is shown in Figure 63. Bridge rail damage was considerable and consisted of complete anchorage failure of the metal parapet in the impact zone. This downstream section of the metal parapet was completely torn and twisted from the concrete walk. Damage to the concrete parapet on which the vehicle came to rest was minor and consisted of scraping of the concrete because of sheet metal contact.

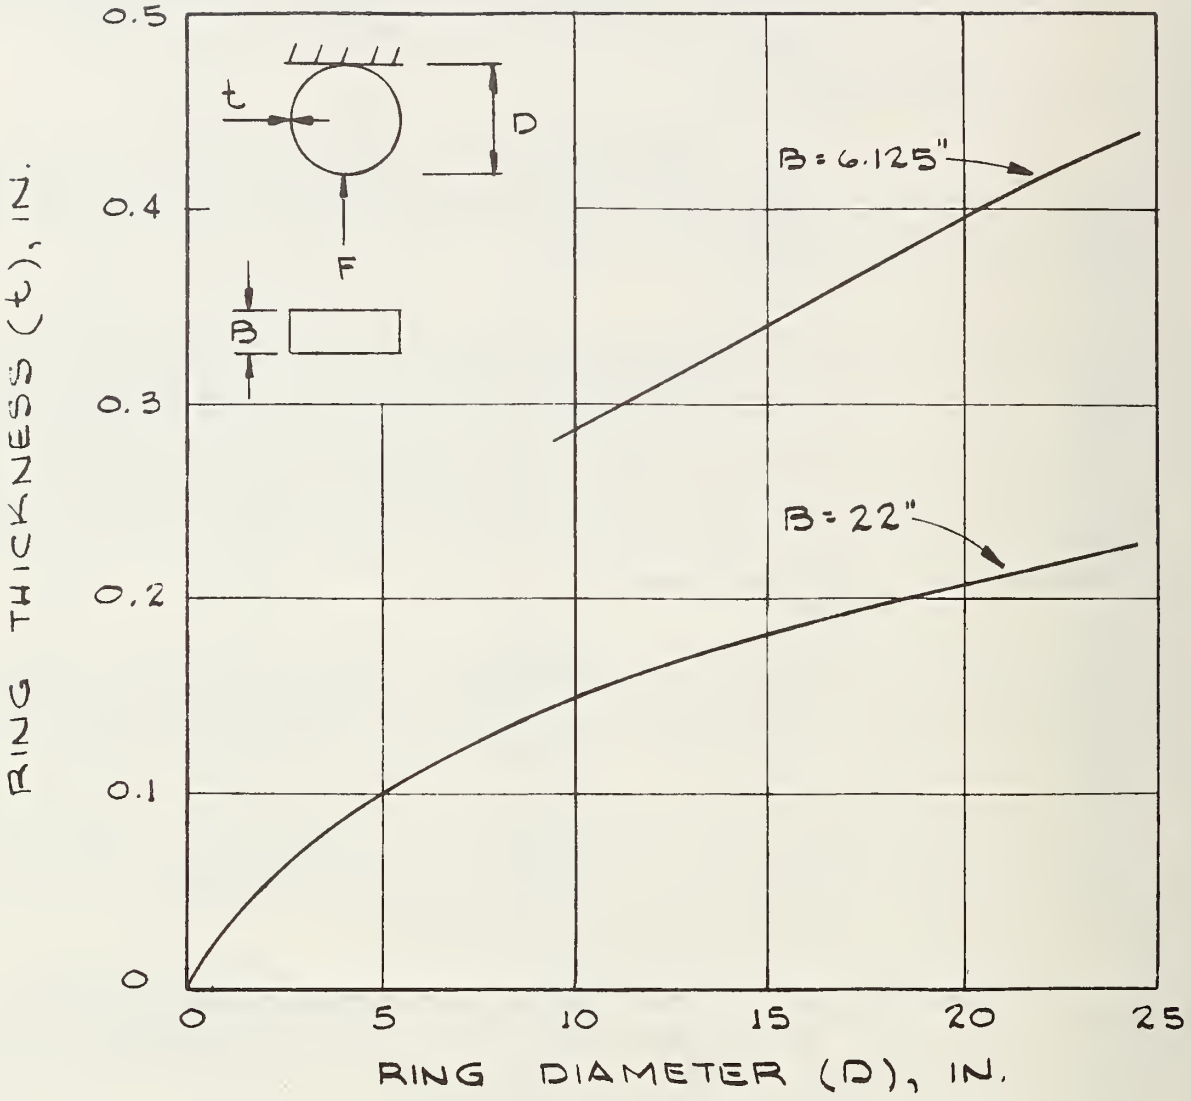
FIGURE 75. COLLAPSING RING THICKNESS REQUIREMENT

where B is the width, R is the radius, t is the plate thickness, and C is the crush constant; C is determined to be 0.0957. For the 21-in. (0.53 m) wide thrie beam, a 22-in. (0.56 m) wide ring is required. Ring thickness is shown in Figure 75 for various diameter rings.

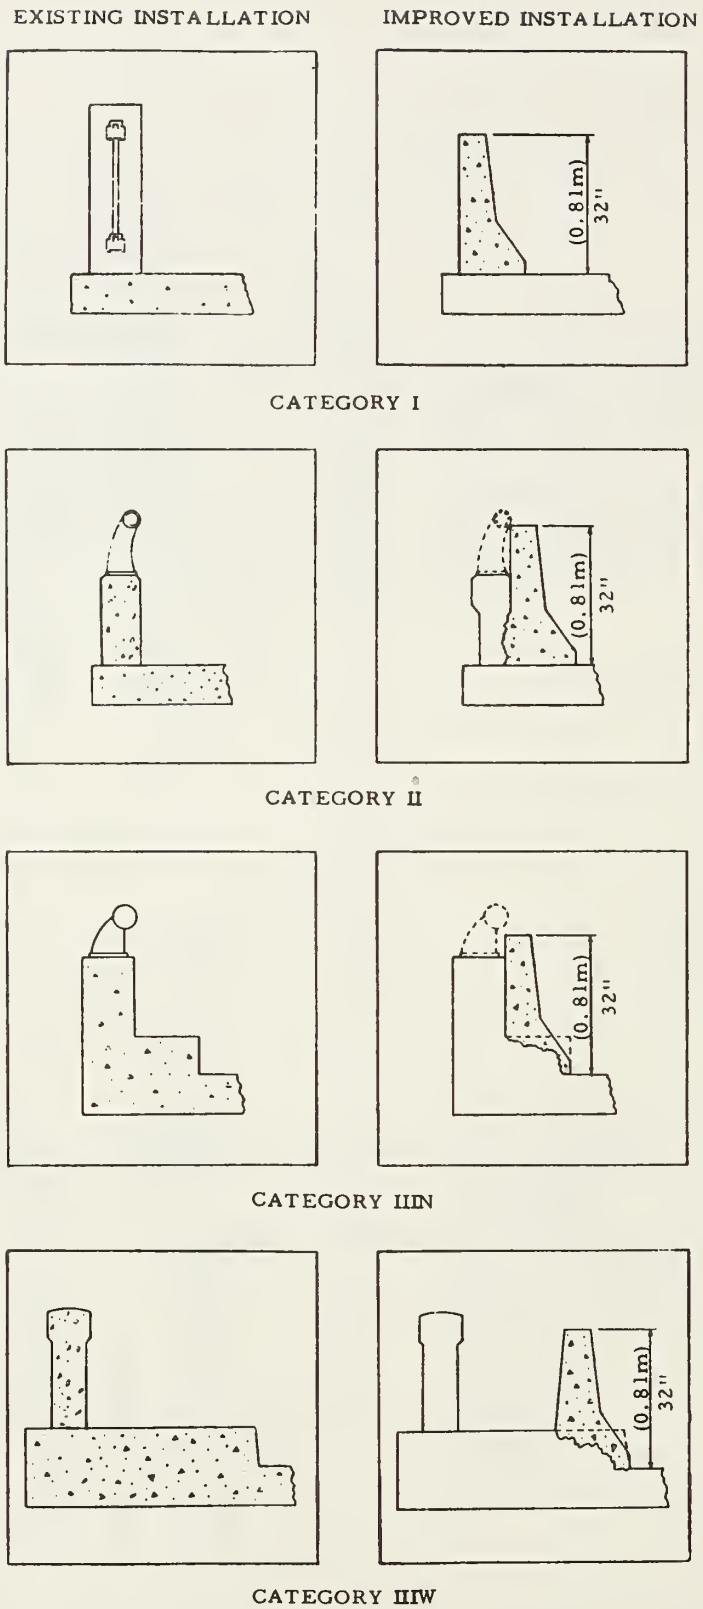
FIGURE 77. CONCRETE SAFETY SHAPE RETROFIT APPLICATIONS

Typical applications of the concrete safety shape to bridge railing categories are shown in Figure 77. It is recognized that these are general design schemes and do not show specific details that will undoubtedly vary from bridge to bridge. Sound engineering judgment and detailed design procedures will be required for application of the concepts.
